Re: STB Finance Docket No. 35305
Petition of Arkansas Electric Cooperative Cooperation's for Declaratory Order

BEFORE THE
SURFACE TRANSPORTATION BOARD

STB Finance Docket No. 35305

ARKANSAS ELECTRIC COOPERATIVE CORPORATION'S
REBUTTAL EVIDENCE AND ARGUMENT

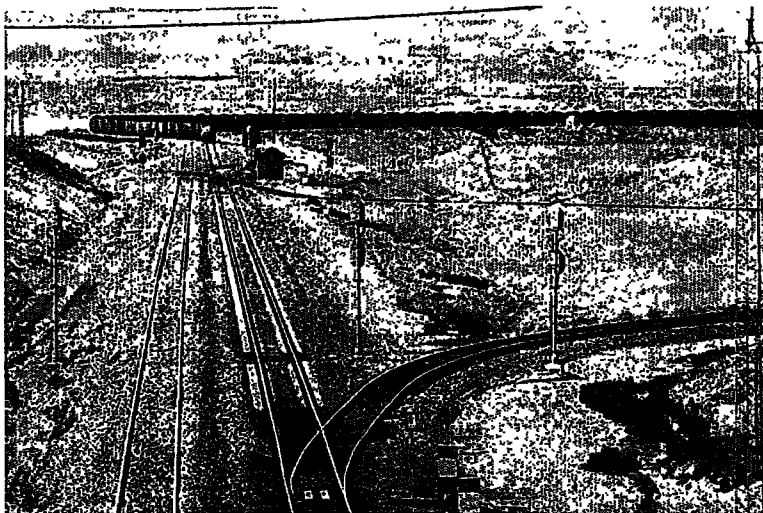
As is plainly visible on the left side of the photo, there is no access road, and ruts resembling tire tracks have been cut into the lower portion of the embankment, introducing embankment material into the drainage area. The photo [REDACTED]
